Last Modified: 2-12-2007		1.6 A
Service Category: Engine/Hybrid System	Section: Engine Mechanical	
Model Year: 2008	Model: xB	Doc ID: RM0000032Z9000X
Title: 2AZ-FE ENGINE MECHANICAL: ENGINE UNIT: REMOVAL (2008 xB)

REMOVAL

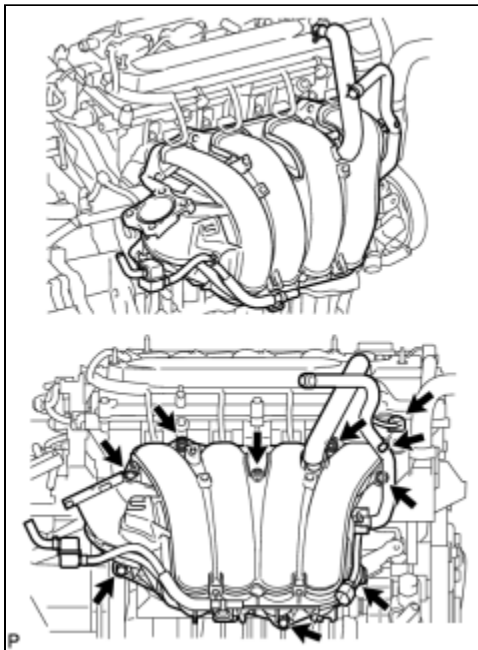
1. REMOVE FUEL DELIVERY PIPE SUB-ASSEMBLY [INFO](#)
2. REMOVE FUEL INJECTOR ASSEMBLY [INFO](#)
3. DISCONNECT NO. 2 VENTILATION HOSE [INFO](#)
4. REMOVE INTAKE MANIFOLD

- (a) Disconnect the camshaft timing oil control valve connector.
- (b) Remove the wire harness clamp.
- (c) Remove the 5 bolts, 2 nuts and intake manifold.

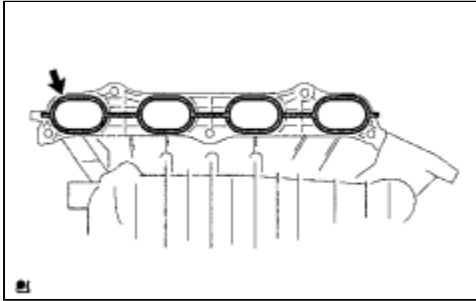
- (d) Remove the gasket from the intake manifold.

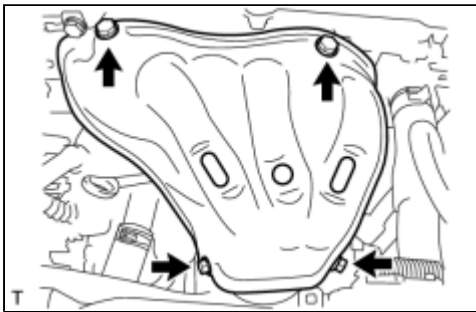
6. REMOVE NO. 1 EXHAUST MANIFOLD HEAT INSULATOR

(a) Remove the 4 bolts and No. 1 exhaust manifold heat insulator.

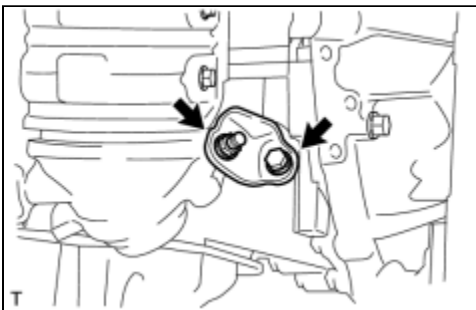
7. REMOVE MANIFOLD STAY

(a) Remove the bolt and nut, then remove the manifold stay.

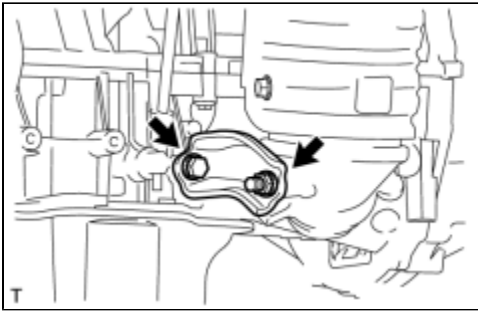
8. REMOVE NO. 2 MANIFOLD STAY

(a) Remove the bolt and nut, then remove the No. 2 manifold stay.

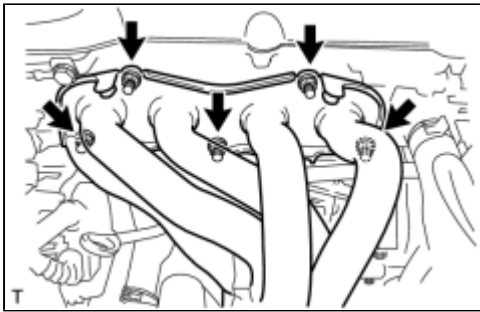
9. REMOVE EXHAUST MANIFOLD CONVERTER SUB-ASSEMBLY

(a) Remove the 5 nuts and exhaust manifold converter.

(b) Remove the gasket.

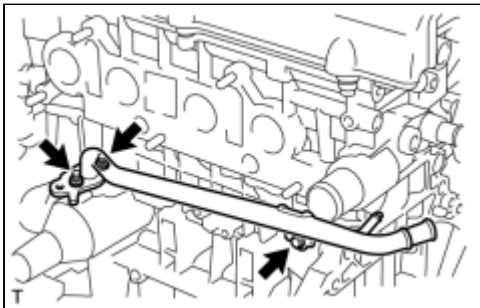
15. REMOVE NO. 1 WATER BY-PASS PIPE

(a) Remove the bolt and 2 nuts, then remove the No. 1 water by-pass pipe.

(b) Remove the gasket.

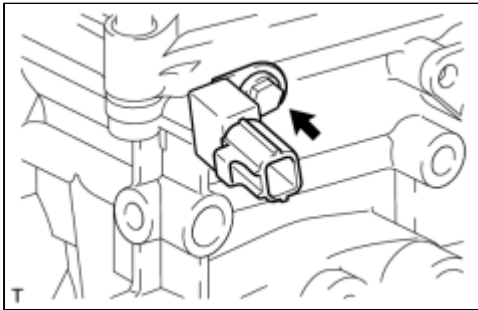
20. REMOVE RADIO SETTING CONDENSER

(a) Remove the bolt and radio setting condenser.
